NASA Technical Paper 1584

# Lubrication and Wear Mechanisms of Polyimide-Bonded Graphite Fluoride Films Subjected to Low Contact Stress

Robert L. Fusaro  
*Lewis Research Center*  
*Cleveland, Ohio*

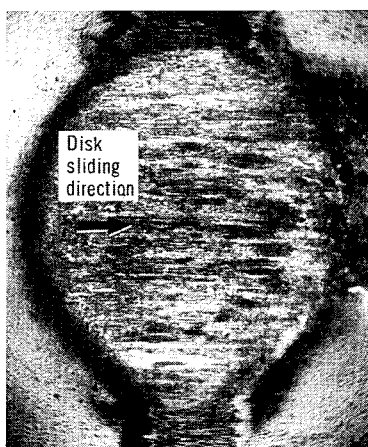
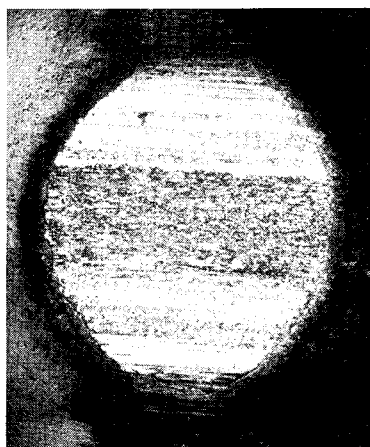
Figure 12. - Photomicrographs of 440C HT stainless-steel rider contact area after various intervals of sliding on polyimide-bonded graphite fluoride films. Disk substrate material, 440C HT stainless steel; load, 1 kg; estimated contact stress, 14 MPa (2000 psi); sliding speed, 2.6 m/sec; temperature, 25°C; atmosphere, moist air (10 000 ppm H<sub>2</sub>O).

A photomicrograph of the rider flat before sliding is shown in figure 12. Also shown in figure 12 is the same rider flat after sliding intervals of 1, 250, 1500, 4500, and 8500 kilocycles. Figure 12(b) shows that initially very thin transfer occurred on the rider flat. Figure 13(a) is a high-magnification photomicrograph of that transfer. Broad, colorful interference bands are visible. On continued sliding, the transfer to the rider gradually increased (figs. 12(b) to (d) and 13(a) to (c)). Comparing the friction trace of figure 2 with the amount of transfer suggests that the friction was lowest when the transfer was thinnest.

Thin transfer films were found on the rider after 6000 and 8500 kilocycles of sliding (figs. 12(f) and 13(d)); however, they looked somewhat different than the thin transfer films found after 1 kilocycle of sliding (figs. 12(b) and 13(a)). Interference fringes were only visible in the entrance of the rider contact area (fig. 13(d)); and the transfer in the contact area itself was milky colored, an indication that the transfer was thinner than the wavelength of light ( $0.4 \mu\text{m}$ ).
